CEILING SYSTEMS DESIGN AND INSTALLATION LESSONS FROM THE CANTERBURY EARTHQUAKES

Rajesh P Dhakal¹⁾, and Gregory MacRae¹⁾

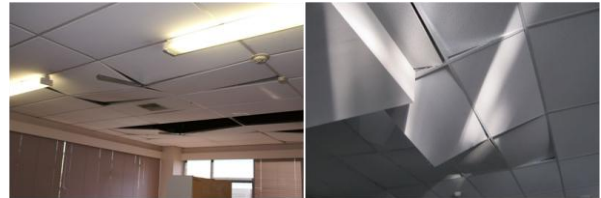
Grid damage results from excessive force on the grid members or connections. This then results in ceiling grid distortion under compression and subsequent buckling of the grid members or failure of the connections while the perimeter connections remain intact. Below are several examples of ceiling grid damage observed in the Canterbury earthquakes.

Figure 2a. Damage resulting from disconnection of cross-tee from the main beam resulting in localized collapse of the grid and loss of tiles (Photos: K Hogg)

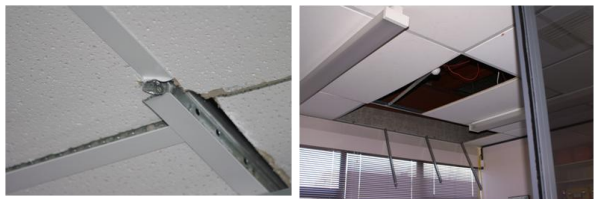
Figure 2c. Damage resulting from main beam splice failure (left) and cross-tee disconnection with main beam (right) (Photos: Hush Interior Ltd)

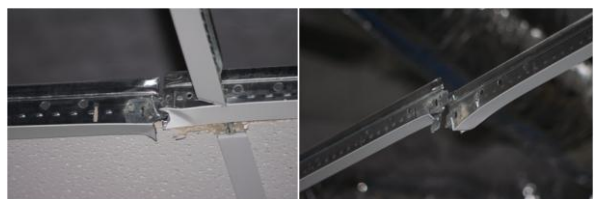
Figure 2d. Damage resulting from main beam splice connection (left) and buckling of cross-tee connections and main beam splice failure (right) (Photos: K Hogg)

The uniformly distributed mass (in the form of tiles) in a ceiling generates uniformly distributed inertial force, and the accumulated inertial force which causes axial compression in the grid members becomes greater near the supports (i.e. the perimeter) than in the middle (Paganotti et al 2011). In general, the observed compression damage of grid members was hence more severe near the perimeter, whereas failures due to tension and connection fracture did not follow a specific spatial pattern.

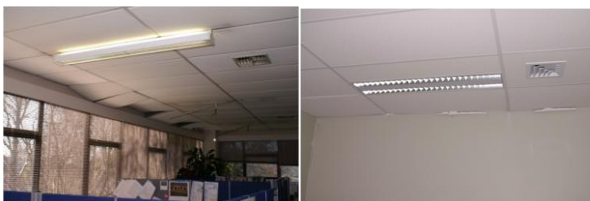
Perimeter damage results from the main tee or cross-tee losing seating on the perimeter angle around the ceiling. Loss of seating can result due to a lack of a rivet to connect the grid member to the angle or failure of the rivet itself. This results in the grid members and tiles dropping from the ceiling. Edge perimeter hanging wires can prevent the member and tiles from falling, however, this can result in the tile and members being forced back into the angle causing damage to the tiles and members; see Figure 3a (right) below.

Figure 3a. Damage caused by disconnection of main beams and cross-tees. Note damage to panels at right which have not dropped from the ceiling but have been forced back into the wall angle causing damage (Photos: Hush Interior Ltd)

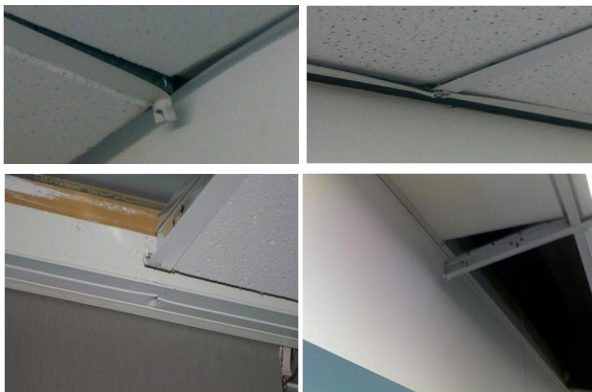
Figure 3b. Damage caused by failure of rivet between main beam/cross-tee and wall angle (Photos: Hush Interior Ltd.)

Common current practice is to connect the grid members to the perimeter angle with centre single-size riveting which only connects to the face cap. Such a riveting system was found to be inadequate. In some cases, the inadequate rivets were observed to fail in tension, leaving only the aluminum cap to hold the system together. In other cases, the rivets were also found

to have ripped through the steel wall angles and tee rails. Probably, the standards need to provide detail specifications on the number, size and locations of rivets for such perimeter connections.

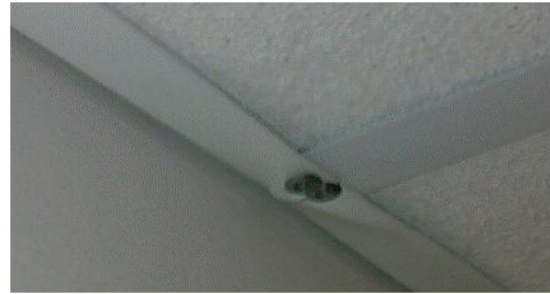
In one case, during repair after the February earthquake damage, engineered tee connections were provided with an increased number and diameter of rivets. This detail survived the June 13 earthquake and the quakes afterwards. Only the trim suffered a small amount of distortion. A photo of this connection is shown in Figure 3c.

Figure 3c. Perimeter connection with increased number/diameter of rivets (Photo: K Hogg)

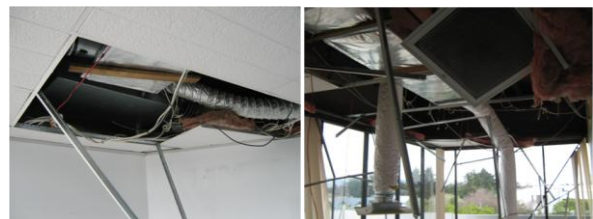
Damage to suspended ceilings can result from force transferred from services above the ceiling into the ceiling itself. In a standard installation of a suspended ceiling the hanger wires are placed at 1200 mm centre. However, the presence of services (such as HVAC) above the ceiling can mean this is not possible. As a result suspended ceilings are sometimes partially hung from services within the ceiling (most commonly HVAC ducting and plant). As this plant is rarely secured properly, when it moves it imparts force into the ceiling, causing damage. Additionally, services above the ceiling moving during an earthquake can impact the hanging wires of the suspended ceiling, once again imparting force into the ceiling. Suspended ceilings are not designed to take the additional force from this plant. Grills within the ceiling plane were often observed to have fallen from the ceiling and localized loss of tiles often occurred around the location of these grills. Some instances of ceiling failures resulting from the interaction with the services are shown in the figures that follow.

Figure 4a. Damage caused by interaction with services above the ceiling (Photos: Hush Interiors Ltd.)

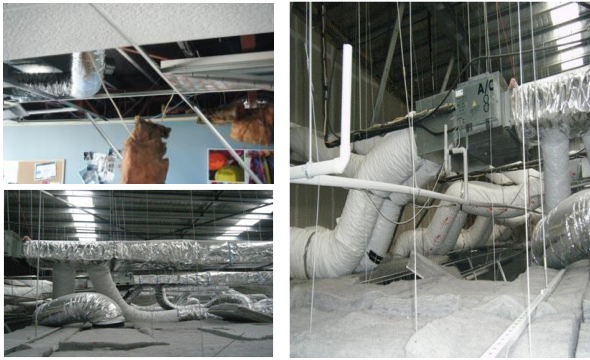
Figure 4b. Damage caused by unbraced AC ducts swaying or causing damage (Photos: R Dhakal, K Hogg)

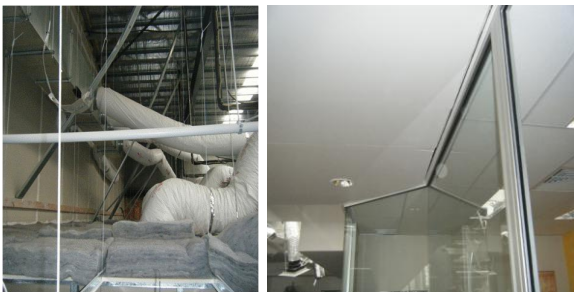
Interaction with partition walls also caused damage to some ceilings braced to the walls. Some internal walls extend to the floor above and are fixed either directly to the floor or beam or through inclined braces which are required to minimize buckling of slender walls. In some cases the ceiling may also be supported on these internal walls. The braces of these walls are close to the ceiling hangers and other equipment braces and are likely to interact with the system. It was found that the failure of the braces (some of which fell off) could easily have caused significant damage to the ceilings (see Fig 4d left).

Figure 4d. Interaction between internal walls and ceiling (Photos: K Hogg)

aluminum sections they are difficult to brace. In some buildings, such wall partitions were found to be out of plumb and in one glazed partition, glass jumped out of the top track (see Fig 4d right).

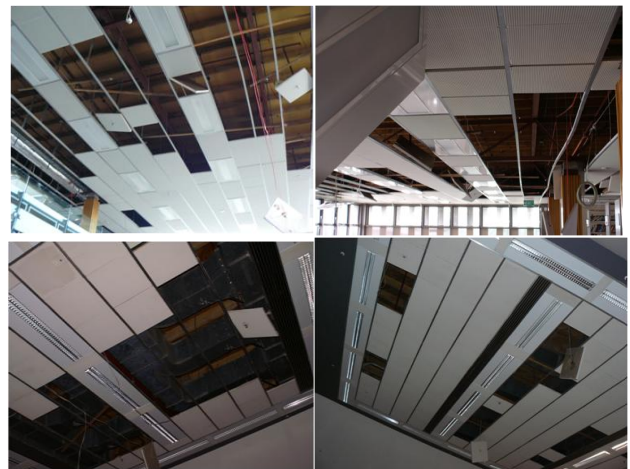
The damage shown in the photos below occurred to grids that are different to the two-way type grid discussed in the previous sections of this report. The grids below consist of main beams spanning one way and hung from the structure above. There are typically no transverse runners (except where the ceiling may have been retrofitted with these). The drop-in panels prevent the grids from spreading apart during an earthquake. However, if panels do drop out there are no members to stop the grids moving apart (spreading) and causing further panels to fall from the ceiling. Also, as opposed to the two-way systems discussed above, the panels are not supported on all four edges by the grid system. The panels are instead interlocked, so when one panel falls it leaves the next panel susceptible to falling.

Figure 5. Damage caused by grid spreading causing the panels to fall from the ceiling (Photos: T Abu and Hush Interior Ltd)

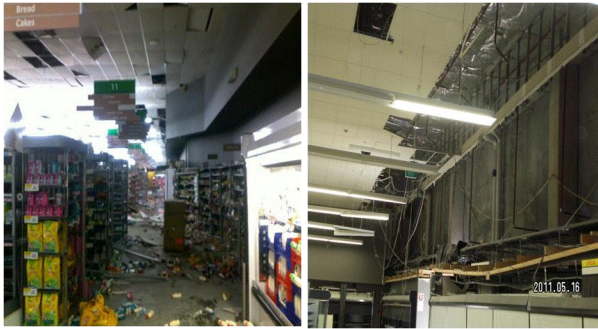
Damage to suspended ceilings can also result from elements that are connected to the ceiling but should be independent of it. Common examples of this are timber or steel framed bulkheads and partitions. Partitions, in particular, should not rely on lateral support during an earthquake from the suspended ceiling. Unless it is considered explicitly in design, this type of construction applies extra force into the ceiling and can result in damage (see Fig 6a for example).

Figure 6a. Damage due to interaction between bulkheads and ceiling (Photos: K Hogg)

In some cases damages were attributable to the interaction between ceilings and bulkheads. Bulkheads hanging from tiled ceilings dropped when the ceiling perimeter detail failed. In a building it was found that during renovation, bulkheads were removed but no bracing was put in place to take the ceiling load. In such cases, the partition loads change during alterations and ceiling line load increases, hence it is advisable to provide bracing to take care of the increased load on ceiling.

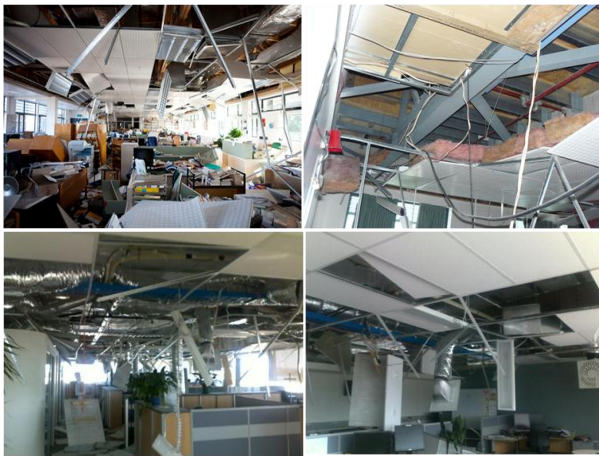
The above forms of damage can occur simultaneously during an earthquake causing widespread damage to a single ceiling system. Some examples of this are shown in the figures below.

Figure 6b. Widespread damage of a single ceiling (Photos: R Dhakal, T Abu and Hush Interior Ltd.)
